8 Reducing sign clutter

Erith – Town Centre Improvements

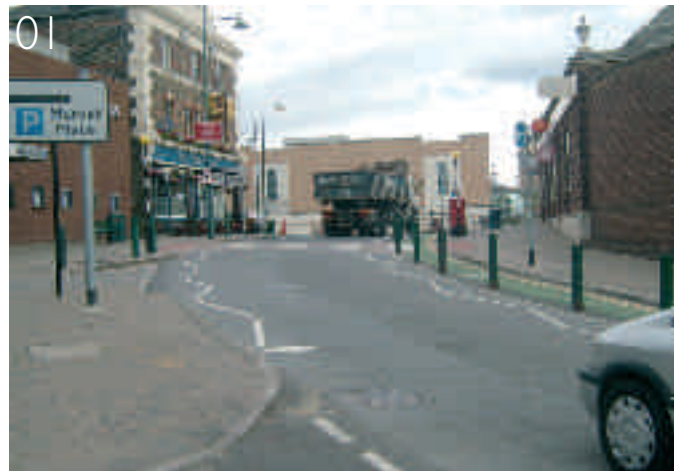
01 Before: Erith's Conservation Area was dominated by oversized and excessive amounts of traffic signage and street furniture

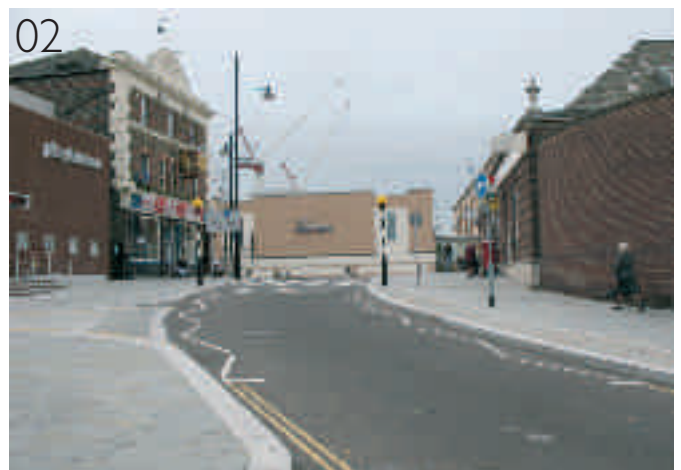
02 After: The reduction of clutter combined with overall public realm improvements improved the character of the area. However the use of new lines is perhaps excessive. The yellow lines may not actually be required at crossovers and could have been lemon or cream coloured to reduce its visual impact

The outcome of the project has been perceived as a success by the local authority as the character of the street has been greatly enhanced by the reduction in street signage clutter without the need to reduce vehicle safety. However, suggestions for future schemes to reduce sign clutter are to include urban designers in the process, eliminating unnecessary signs and posts and exploring opportunities to mount signs on buildings and existing posts, and reduce yellow lines.

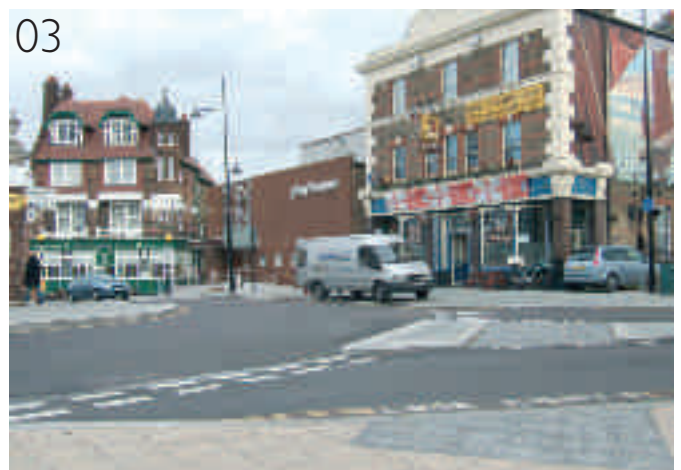
03 Views of the town are significantly improved by the simplification of the street environment

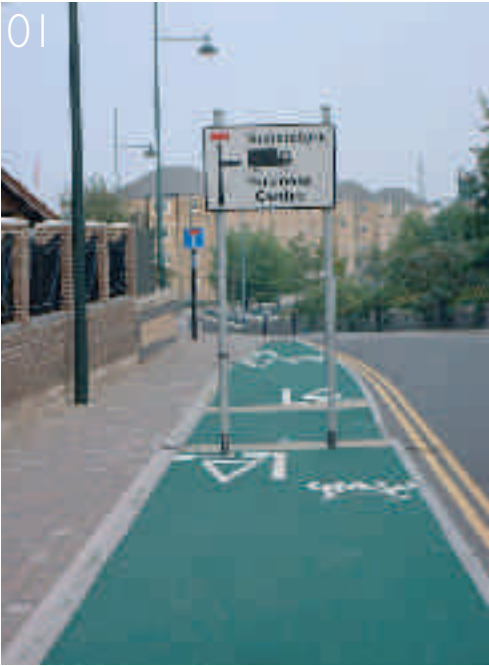
01 Over elaborate signing implemented without any thought to its location and the impact it has on the street environment and the confusion of message it gives

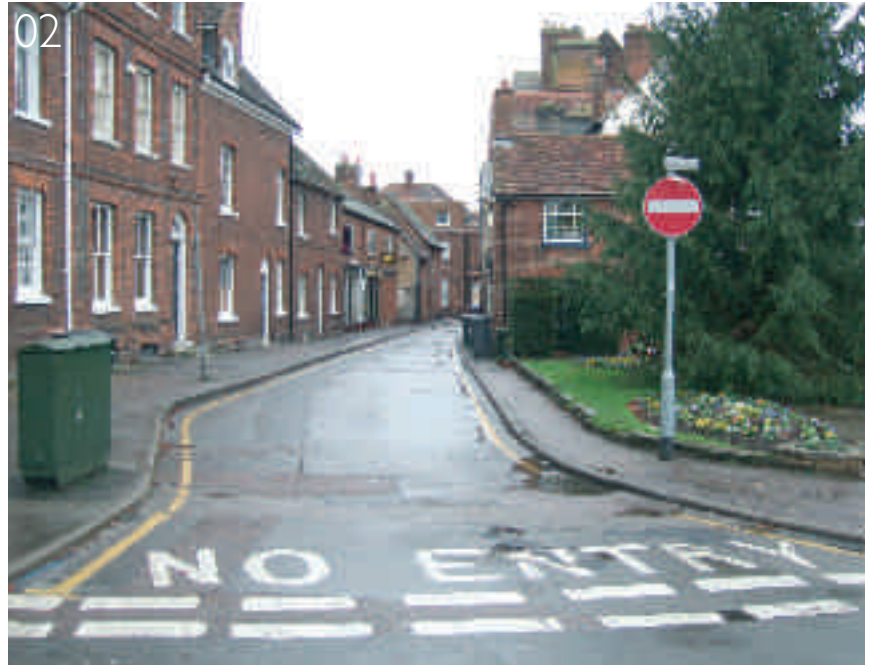
02 An excess of signing – the overall design should remove the need for this through better road alignment and sign location
